# **Technical Report:** **March 2008 Groundwater** **Monitoring Program Results and** **Baseline Ecological Risk Assessment**

**Former JCI Stanley Tools Site**  
**Fowlerville, Michigan**

**April 2008**

# SEMI-ANNUAL GROUNDWATER SAMPLING RESULTS REPORT

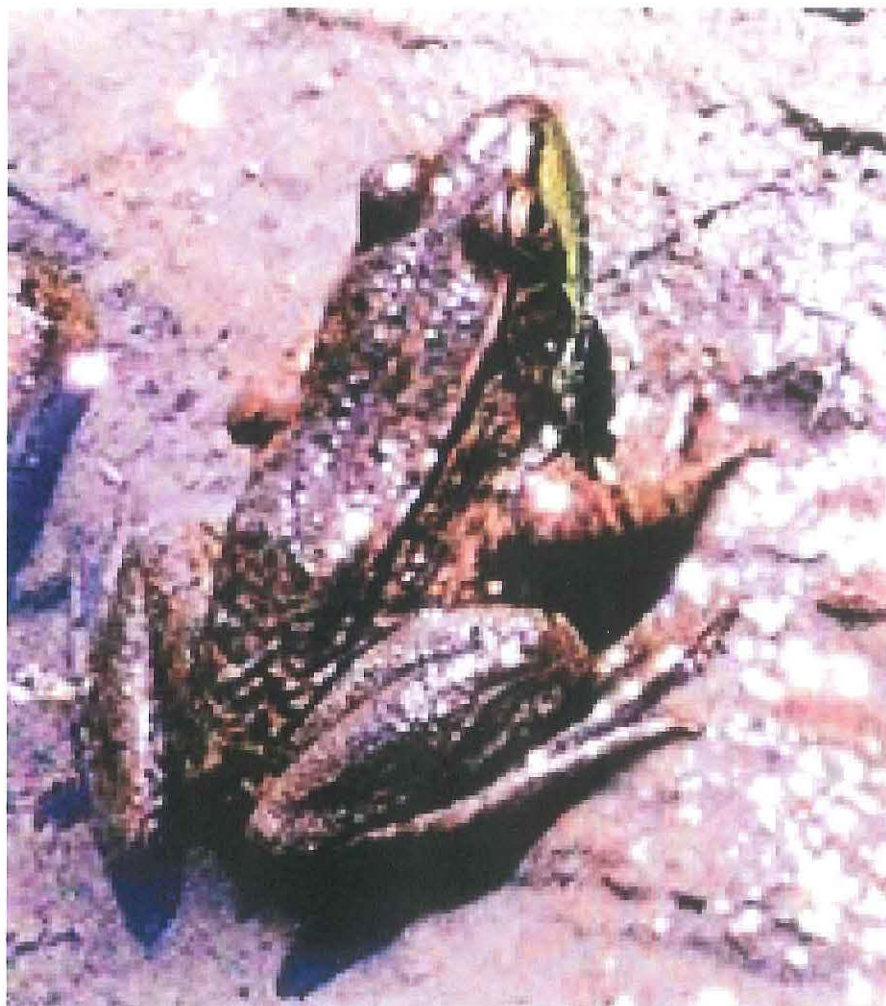
PHOTO 36

SUBJECT: Photograph of wood frog (*Rana sylvatica*) on emergent log along river bank near location of community survey station 04.
